# CASE STUDY

SLALEY HALL

DE VERE HOTELS

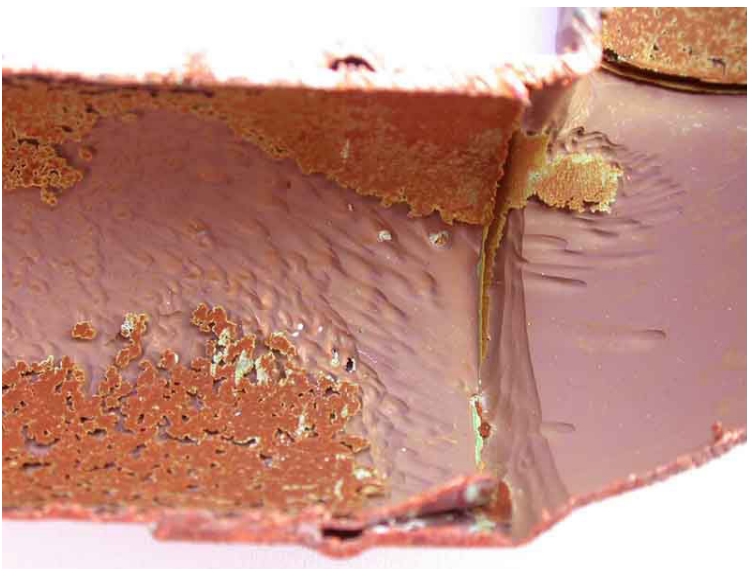
Erosion corrosion at a 22mm elbow from Slaley Hall, showing removal of protective patina on copper and grooving of copper

Dr Munn's report showed that the cause of the leaks was erosion corrosion and that the unusually coloured deposits were found to include manganese and iron. The impurities in the surface scale reduced its protectiveness. Analysis of the supply water showed nothing unusual and the cause of the erosion corrosion was attributed to the design and operation of the system, which led to too high water velocities.

Based on the recommendations in the report, **Barnes & Sons** successfully solved the problem by fitting a Honeywell pressure-reducing valve to the booster pump unit to reduce flow rates below the critical levels for the conditions existing at Slaley Hall. Dr Munn also recommended regularly regenerating a iron/manganese filter, which was already fitted to the incoming mains supply. This would mean that it would operate effectively to remove dissolved iron and manganese from the water.
