Pitting of Copper Pipes in Domestic Water Systems in the UK

Phillip MUNN

Abstract

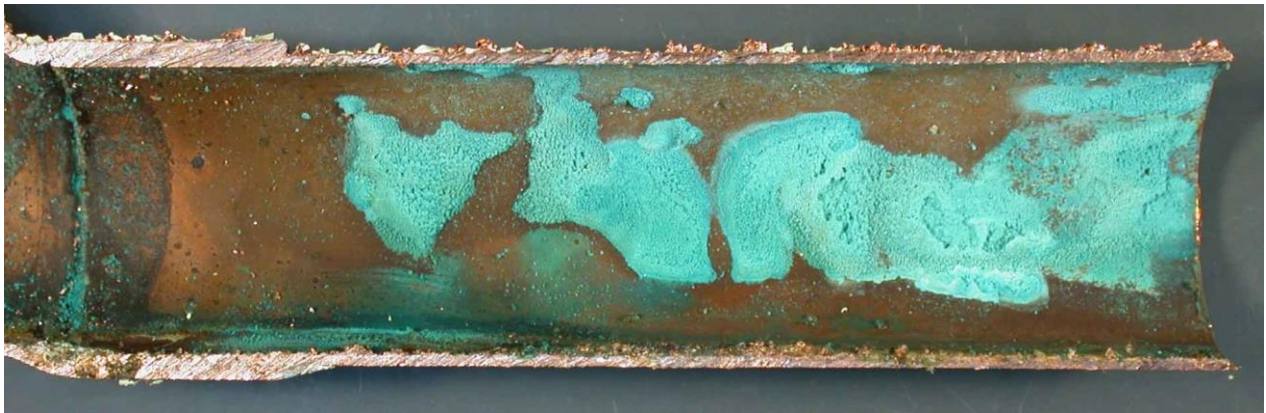
Since the work on the effect of water composition on pitting was carried out at BNF Metals, water companies in the UK have been routinely dosing ortho-phosphate into the supply waters in order to reduce the leaching of lead from old lead distribution pipework. Munn [6] has reported on how the phosphate becomes incorporated into the carbonate patina on copper pipework resulting in it becoming blue in colour and more irregular and less stable. This was found to increase the likelihood of so-called blue water but also appeared to increase the likelihood of type 1 pitting. An example of a pipe exposed to high levels of phosphate in the water is shown in Fig. 3 which contrasts with the appearance of a regular smooth green carbonate scale containing no phosphate (Fig. 4).

Fig. 3 Irregular phosphate-containing carbonate deposit on bore of cold water pipe

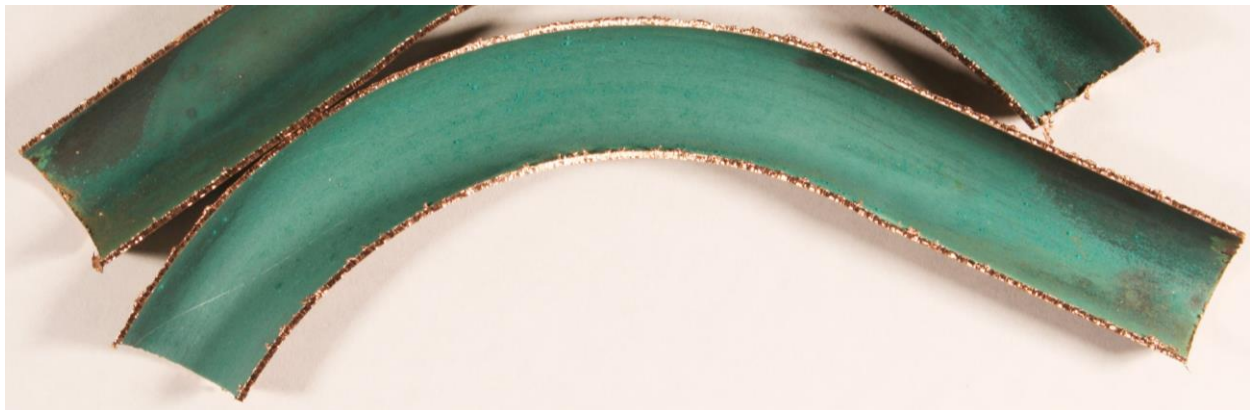
Fig. 4 Regular green carbonate patina formed on cold water pipes

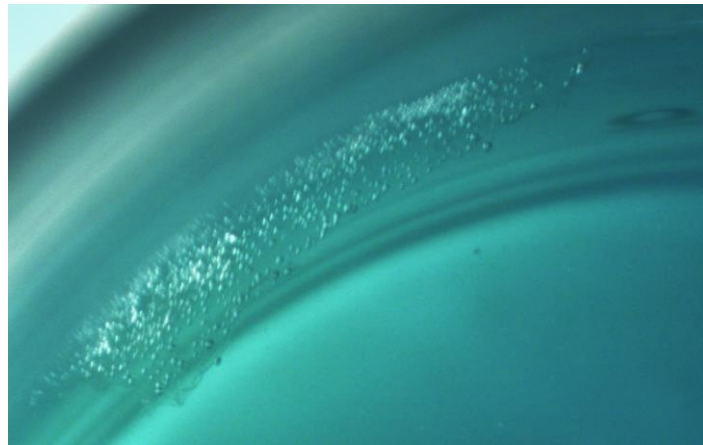
Fig. 5 Typical appearance of biofilm extracted from bore of copper pipe

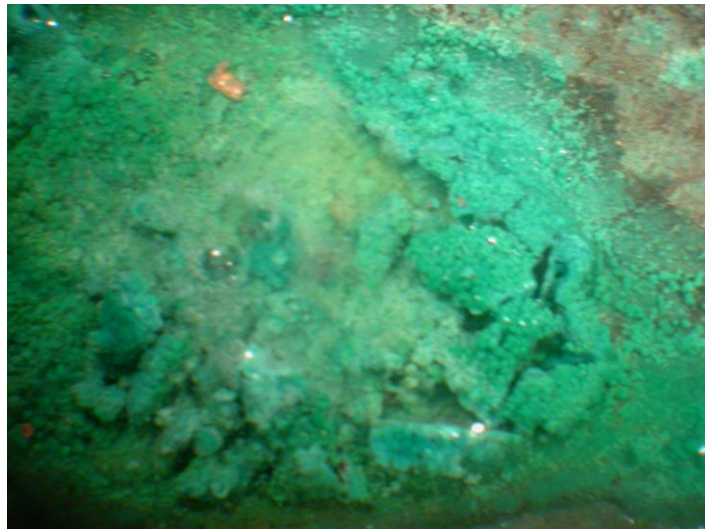
Fig. 6 Nitrogen gas bubbling indicating presence of sulphides in deposits in sodium azide/iodine spot test

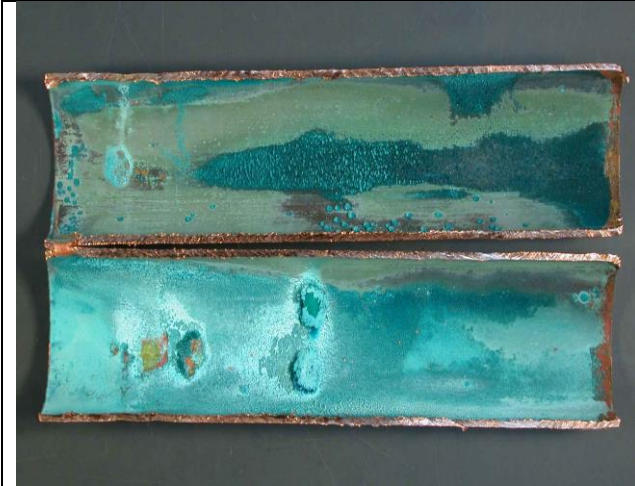
Fig. 7a – Case 4 Type 1 pitting – bore before cleaning

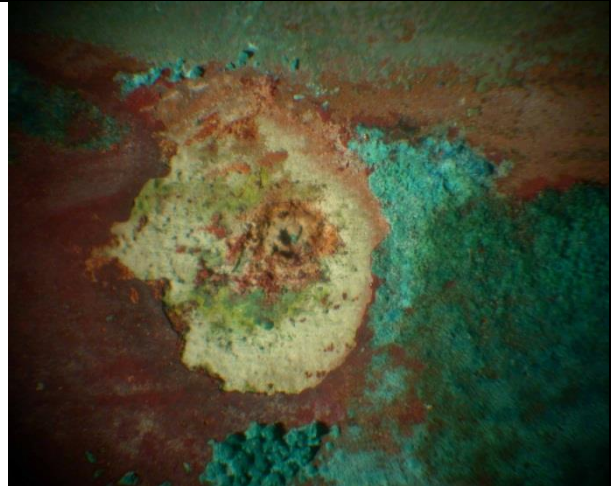
Very few pits are found to be perfectly or even nearly hemispherical, i.e. classic type 1 pits. Figs. 7b and 8b show approximately hemispherical pits, which are clearly type 1. The nodules of copper hydroxycarbonate on the pipe bore are usually located close to the bottom of the pipe and often are elongated due to streaming copper I chloride corrosion products under the action of gravity. A x-section through another type 1 pit from the same case as shown in Fig 8b is shown in Fig. 8c. Here, the copper oxide membrane separating the carbonate mound on top of the pit from the pit in the copper is clearly seen. Note that the pit cavity itself contains several smaller hemispherical pits. A similar looking x-section is shown in Fig. 9b. In this case, widespread pitting attack was found under longitudinal streaks of carbonate along the bottom of the bore.

Fig. 7b – Case 4 Type 1 pitting – close up of pit

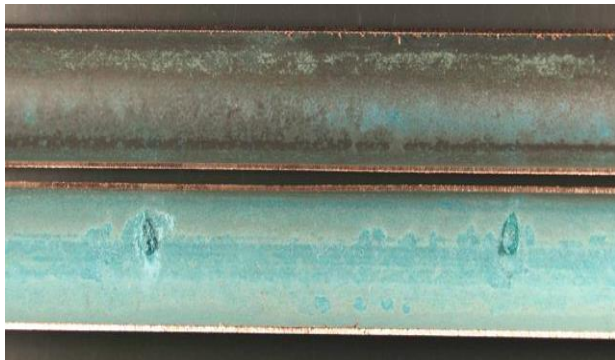
Fig. 8a – Case 15 Type 1 pitting -bore before cleaning

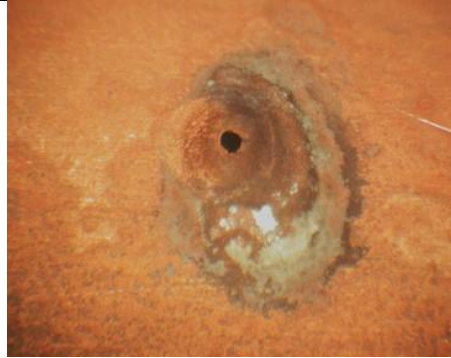
Fig. 8b – Case 15 Type 1 pitting – close up of pit

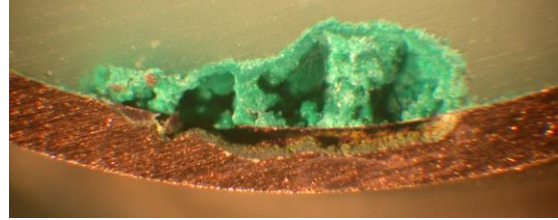
Fig. 8c – Case 15 x-section through pit

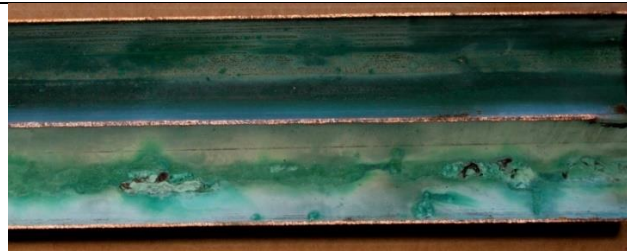
Fig. 9a – Case 23 Type 1 pitting -bore before cleaning

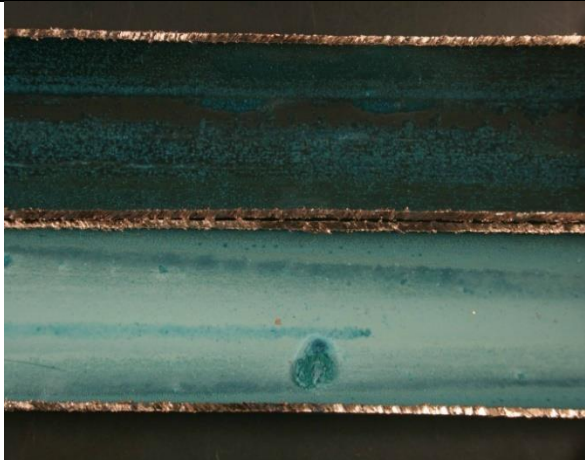
Fig. 10a – Case 7 Type 1 pitting -bore before cleaning

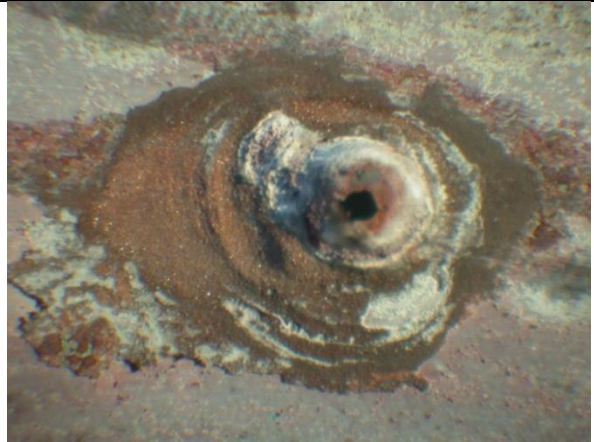
A variation on the shape of a type 1 pit with several rings of attack around a deep central pit is shown in Fig. 10b. The formation of this shape of pit was explained by Lucey when the current path between anode and cathode also passed through the surrounding copper rather than just the copper oxide membrane.

Fig. 10b – Case 7 Type 1 pitting – close up of pit

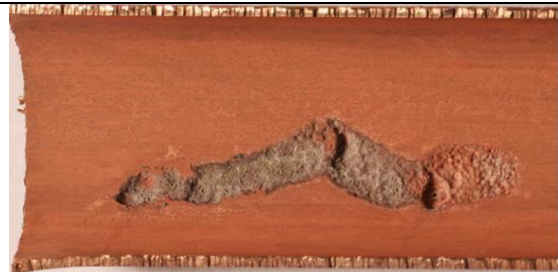
Often elongated mounds of carbonate are found close to the bottom of the pipe. When this is cleaned away, multiple large and small hemispherical pits are revealed, as shown in Fig. 11. Around the edge of some roughly hemispherical deep pits, there are multiple smaller pits, as shown in Fig. 12b.

Fig. 11b – Case 30 Type 1 pitting – close up of pit

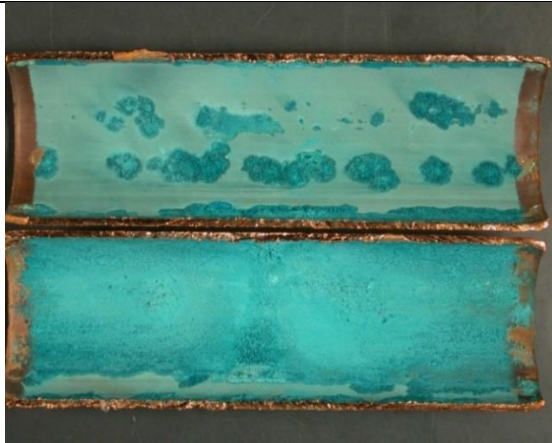
Fig. 12a – Case 8 Type 1 pitting -bore before cleaning

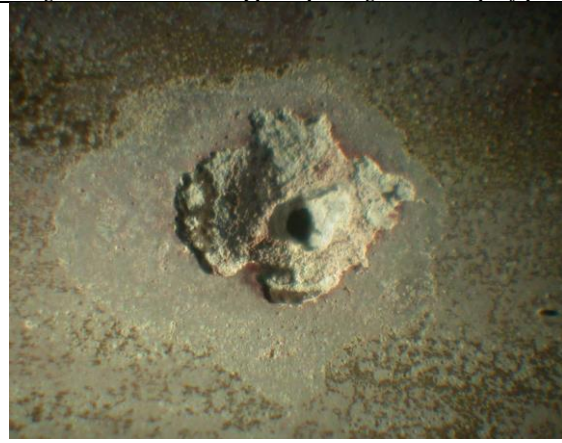
Fig. 12b – Case 8 Type 1 pitting – close up of pit

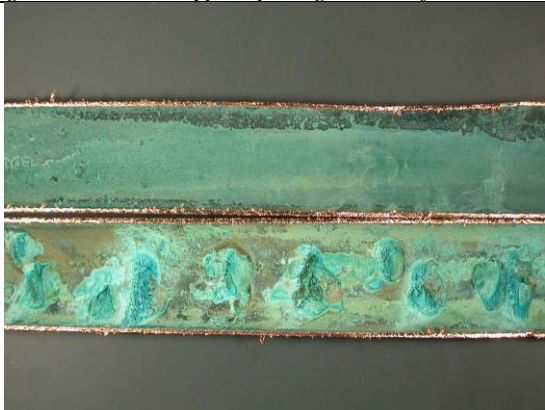
Classic type 3 or MIC pits look completely different to the above examples. Although the carbonate mounds on the bore may look similar to those found with type 1 pits, as shown in Fig. 13a, once these have been removed by cleaning with acid, the underlying attack does not show any large single pits with or without small hemispherical pits. Instead, one sees irregular-shaped steep-sided pits with often multiple smaller deep satellite pits (Fig. 13b). Other clear examples of MIC pits with 'pepper-pot' pitting are shown in Figs. 14 and 15. In these cases, often the bore contains black copper II oxide or other deposits.

Fig. 13a – Case 3 MIC pitting -bore before cleaning

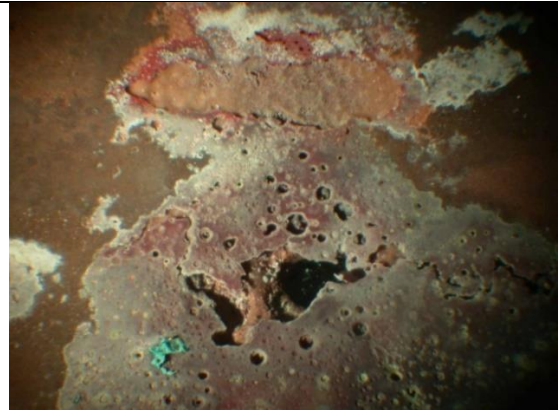
Fig. 13b – Case 3 MIC – pepper-pot corrosion

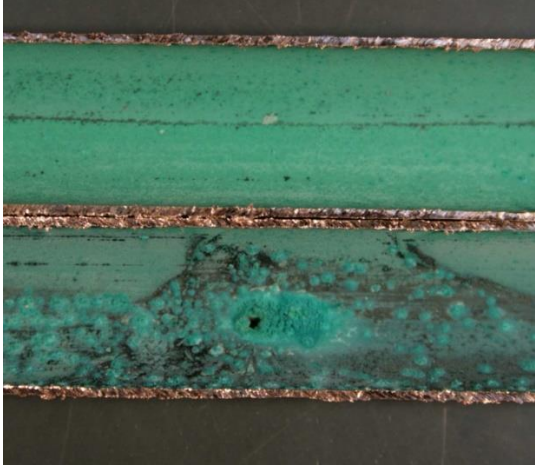
Fig. 14a – Case 10 MIC pitting -bore before cleaning

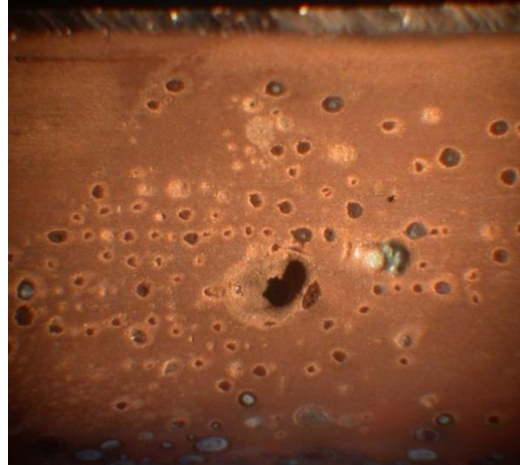
Fig. 14b – Case 10 MIC –pepper-pot corrosion

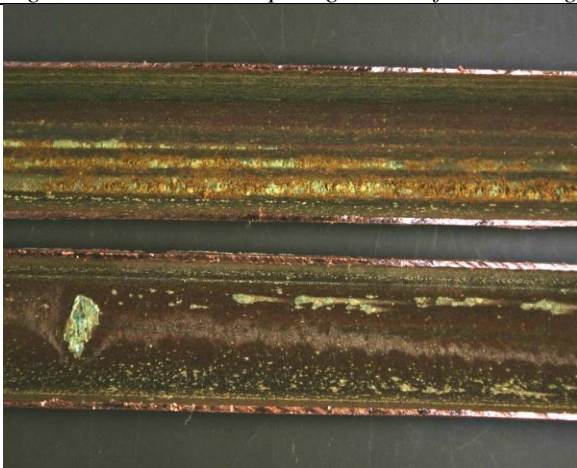
Fig. 15a – Case 9 MIC pitting -bore before cleaning

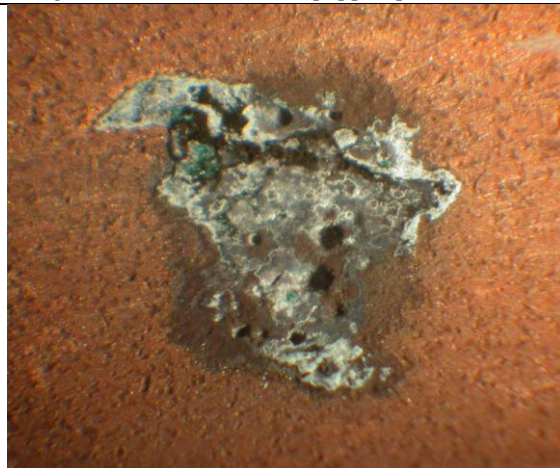
Fig. 15b – Case 9 MIC pitting -pit after cleaning

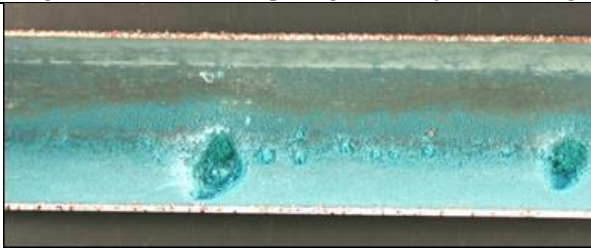
Three examples are shown where the type of pitting is not clear (Figs. 16, 17 and 18). When viewed with the naked eye, the pitting on the bore does appear like type 1. However, the individual pits are found to contain or be surrounded by multiple very small pits, which resemble 'pepper-pot' attack.

Fig. 16a – Case 16 - bore before cleaning

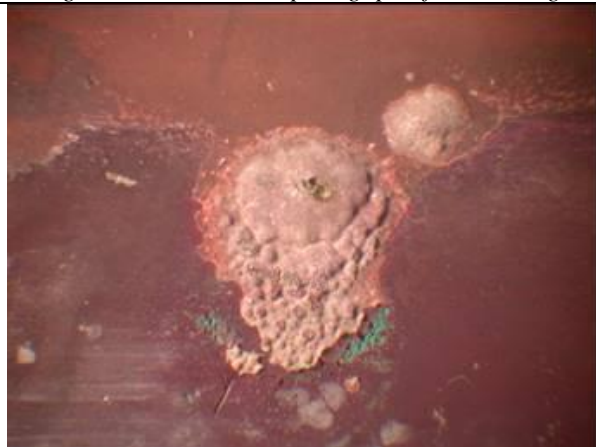
Fig. 16b – Case 16 - pits after cleaning

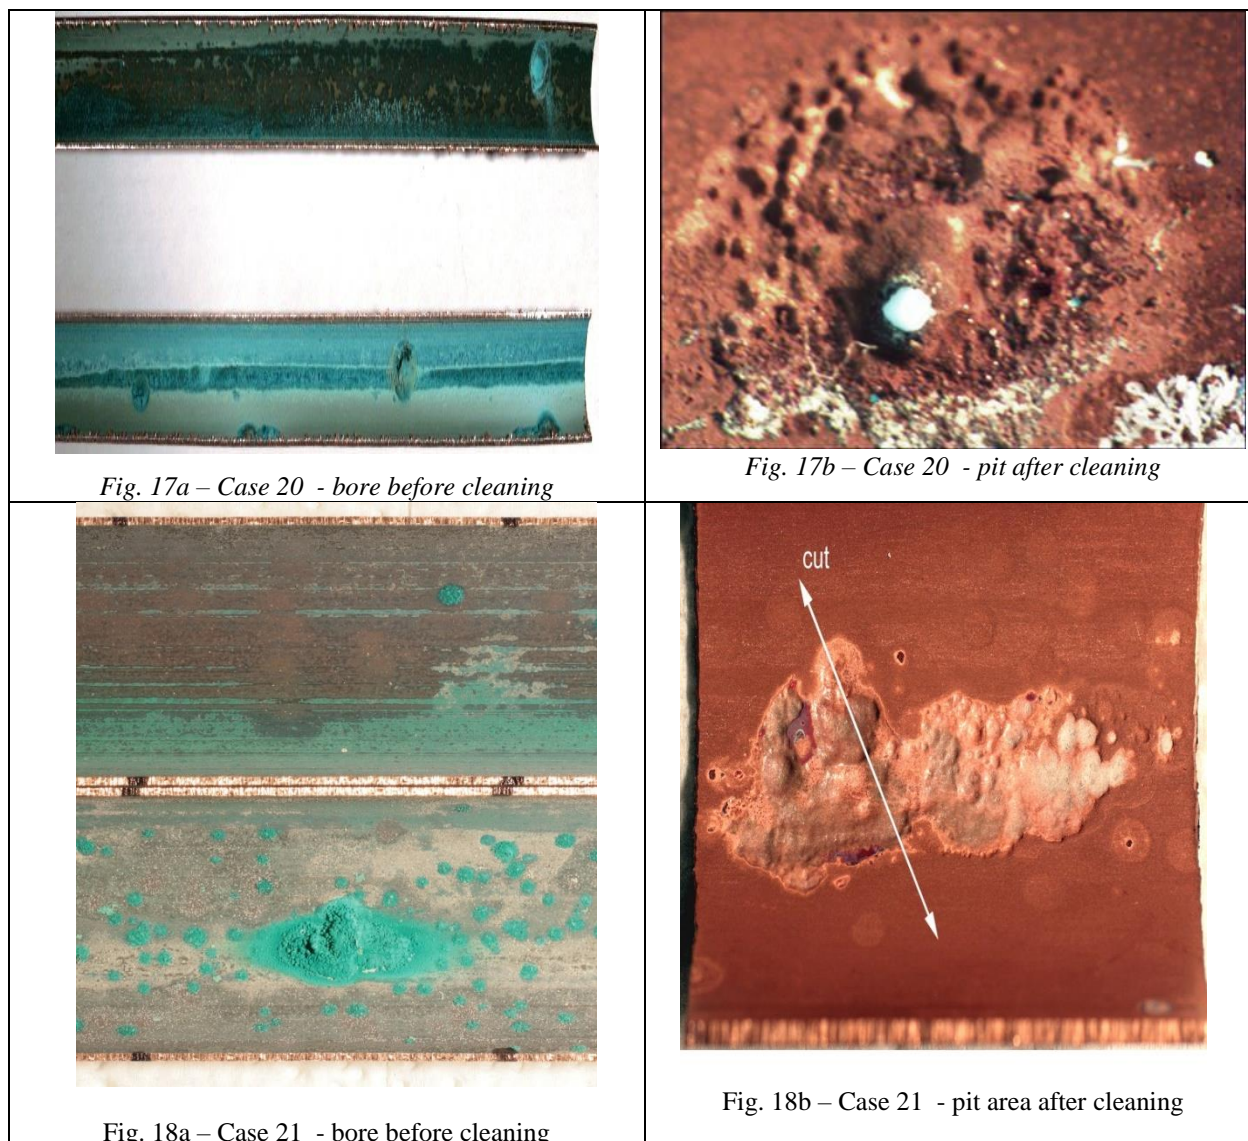
Fig. 17a – Case 20 - bore before cleaning

Fig. 17b – Case 20 - pit after cleaning
